# NPS EFFORTS AT THE BISHOP PAIUTE TRIBE

ENVIRONMENTAL  
MANAGEMENT OFFICE

November 2003

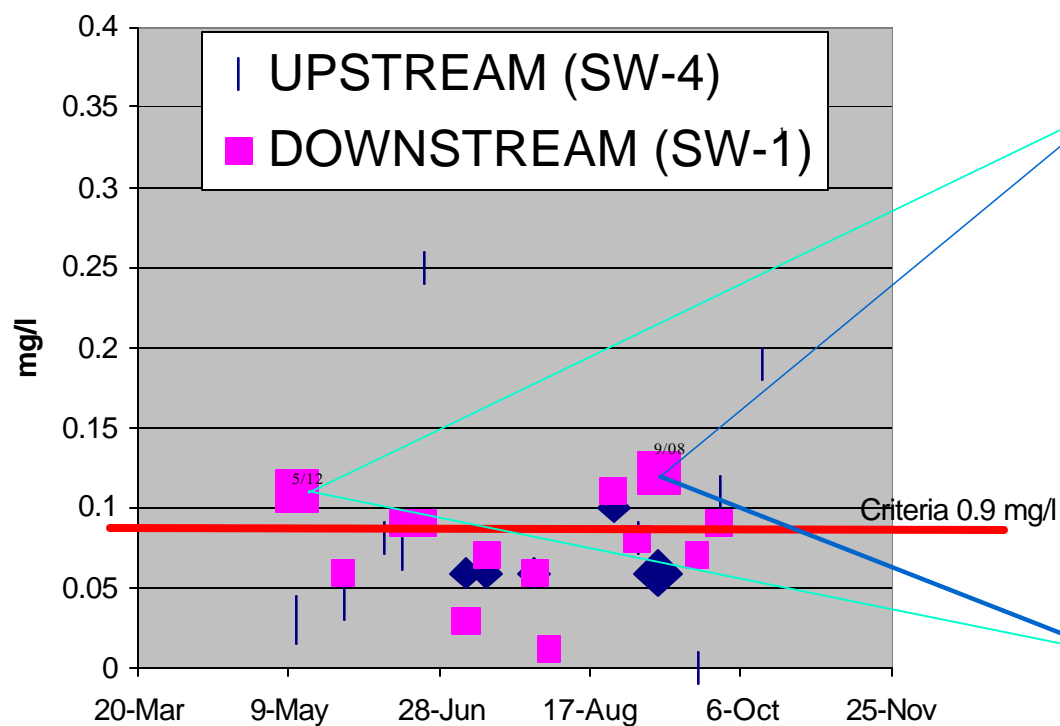
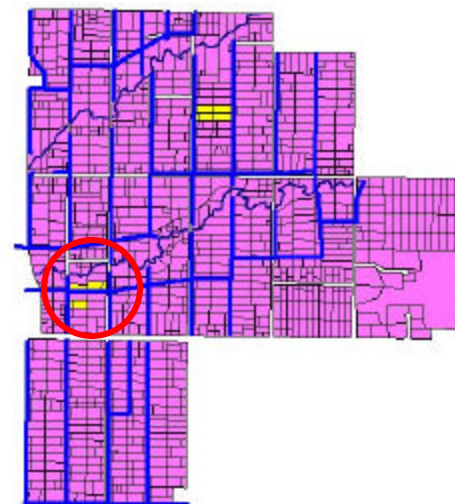
# Nutrients (P04) – S.Fork

## May 12, and Sept 08, 2003

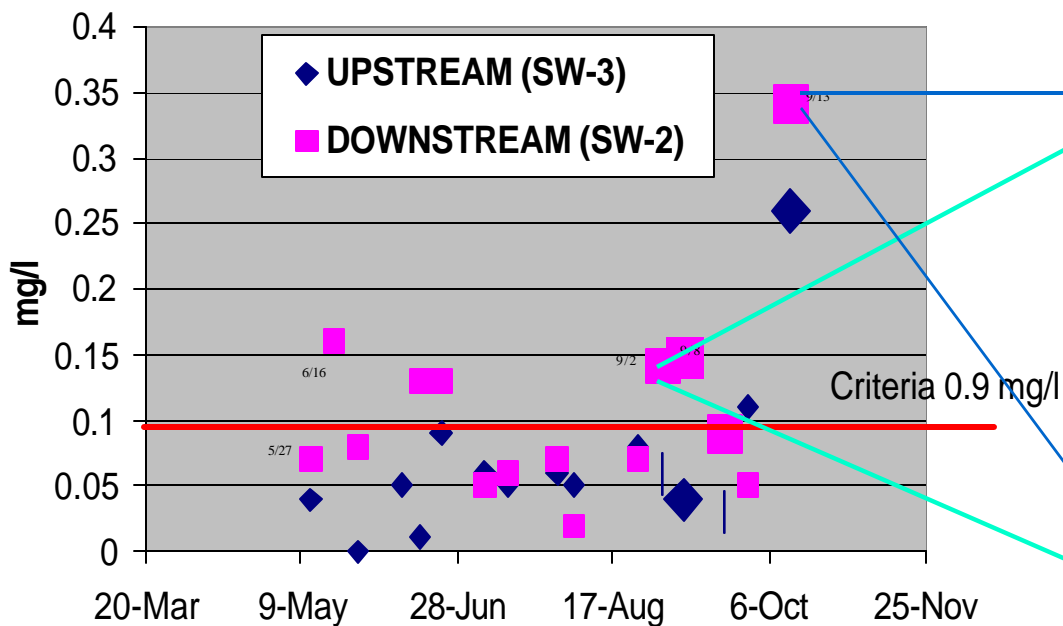
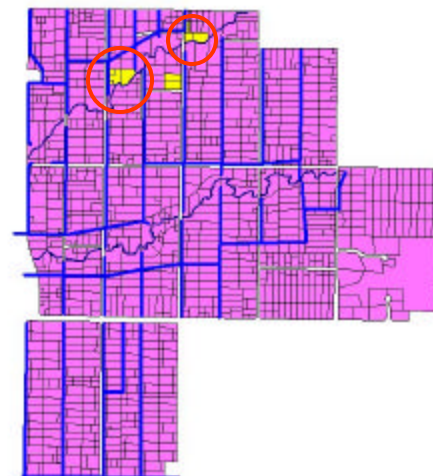
# Nutrients (P04) – N.Fork

## September 2 and October 13, 2003

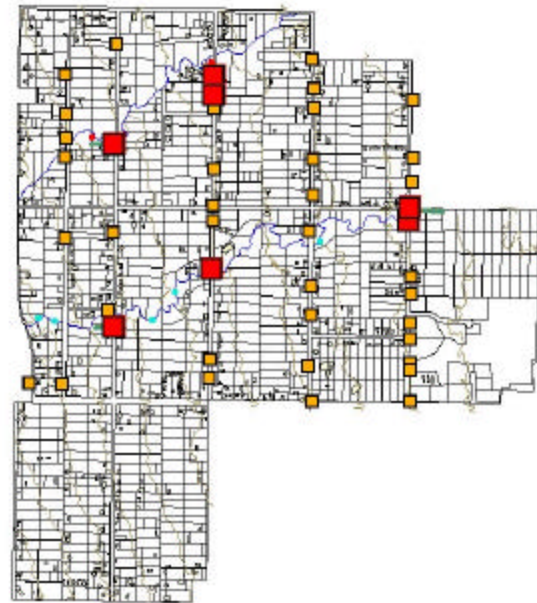
- Tailwater culverts
- Streamside berms
- Riparian corridor restoration

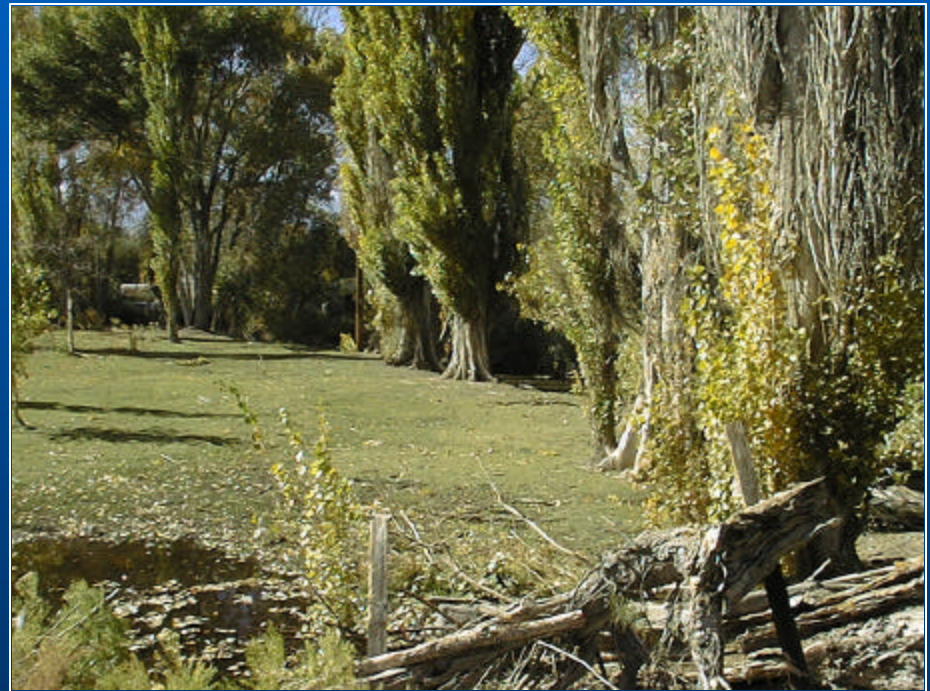
- Tailwater culverts
- Grading
- Riparian corridor restoration

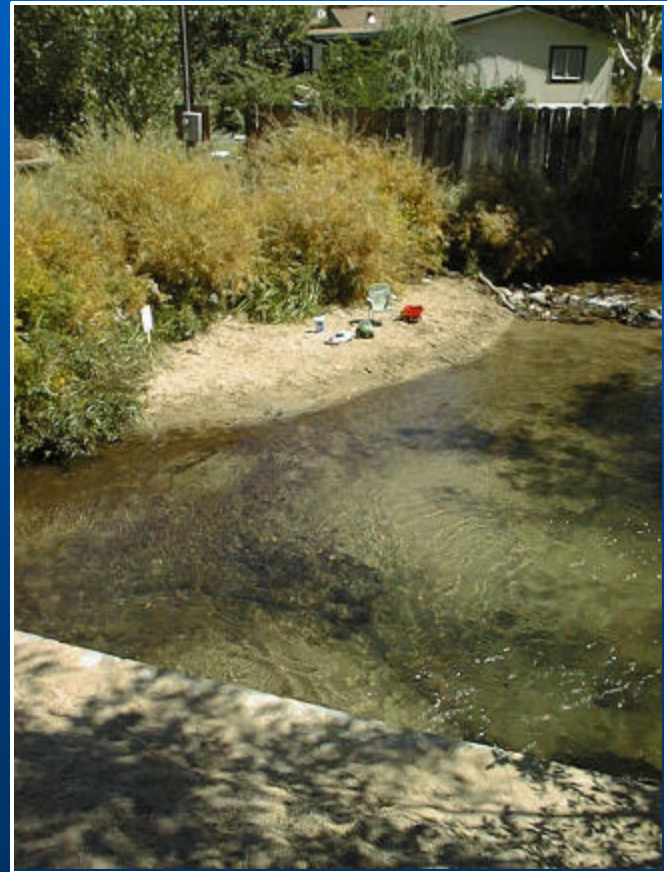
# Swimming Advisories

- **Postings –based upon Geometric Mean**
- **Evaluate with respect to Federal recommended E.Coli standard (126 m.p.n.)**
